II. EXISTING CONDITIONS AND PROBLEMS

The ring of roadways: pollutant deposition & habitat disruption

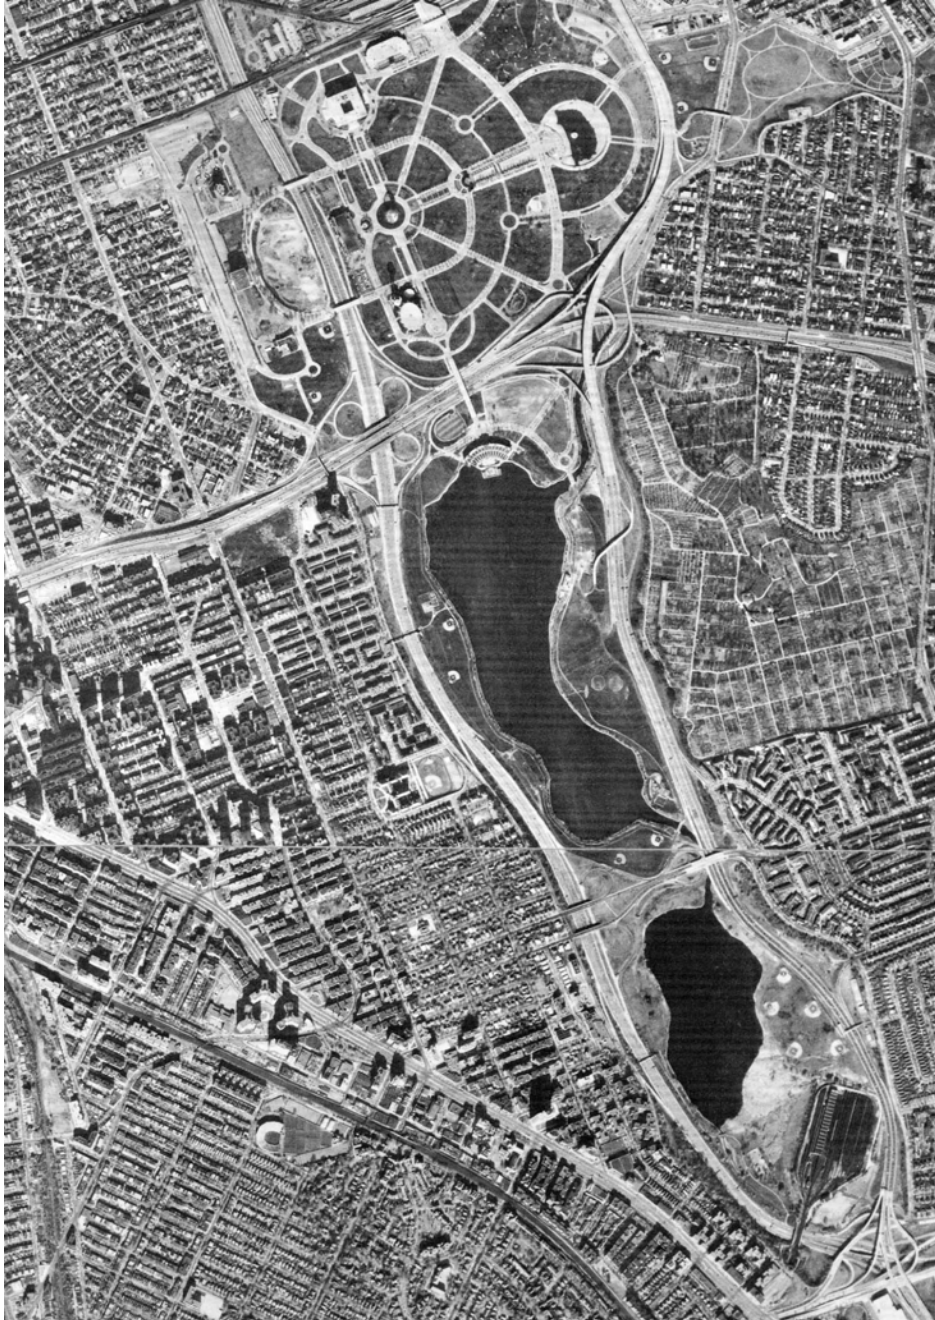
1969 aerial photograph of Flushing Meadows showing the surrounding highways, which limit the natural reintroduction of native animal and plant species.

The simple problem with Flushing Meadows-Corona Park is that it is cut off from the surrounding area by roadway infrastructure. As can be seen in the 1969 aerial photograph of the twin lakes in Flushing Meadows, major highways ring the entire circumference of the park. More than five miles of highway effectively surround the park with a nearly continuous “fence” of high-speed vehicles. This moving barrier deposits a continuous stream of hydrocarbons, nitrate, and metals on the roadway, portions of which are washed directly into the twin lakes.

Reintroduction of native animal and plant species through migration from one side of the highway to the other is severely limited by this high-speed traffic. While birds can fly across the road, there is often roadside evidence of others that do not make it. Toads, frogs, salamanders, turtles, snakes, squirrels, chipmunks, foxes, muskrat, and even smaller animals such as insects have limited opportunities to immigrate from surrounding landscapes, therefore isolating the park from nearby natural areas, in part, by eliminating migrants with a deadly barrier. By reintroducing these species into enhanced, engineered habitats, a diverse ecosystem can be re-established in Flushing Meadows-Corona Park.

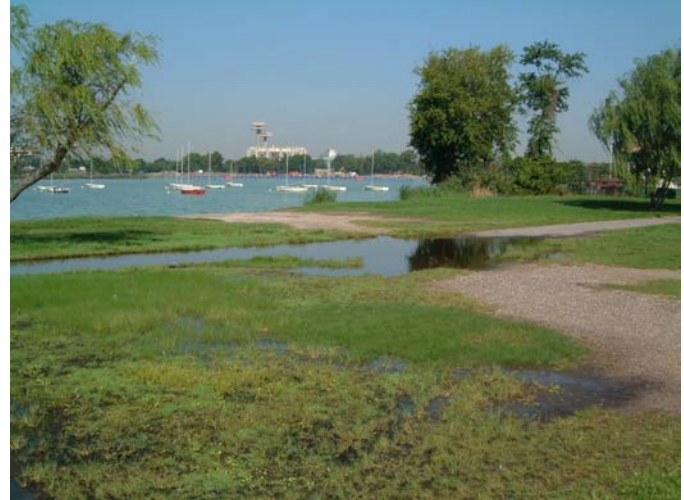
The terrace-like behavior of the infrastructure ringed the twin lakes can be seen adjacent to the highways, parking lots, and pathways, where seeps and upwelling of underground water sources are visible during wet periods or freeze-thaw cycles. The water blockage from these structures causes water to puddle and pool, increasing physical damage caused by freeze-thaw cycles and also increasing potential liability due to accident and injury. One manifestation of this ongoing problem may be seen in the seepages that emerge along the western edge of Meadow Lake following rain events, from the upslope water table that intersects the ground surface and runs across pathways and roads.

In a number of cases, failed pumps, or modified water tables emerge next to or over infrastructure, created more or less permanent wetland features – havens for mosquitoes in summer and ice hazards in winter.

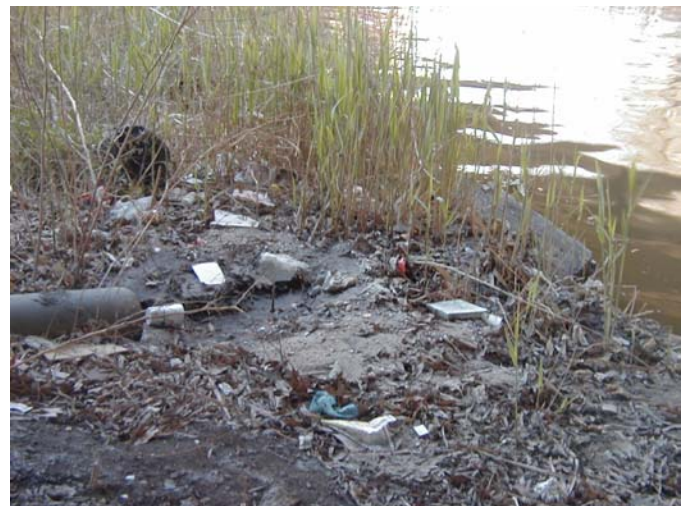
Runoff discharge causes erosion gullies and creates mosquito breeding habitat.

More than five miles of highway around the twin lakes and Flushing Meadows-Corona Park generate, from an inch of runoff, some two hundred thousand cubic feet of water. This runoff has created dozens of erosion gullies around both Willow and Meadow Lakes. The absence of fine-grained materials at the mouths of pipes and along roadway, parking lot and pathway edges indicates that runoff rates of a foot per second or greater has scoured away any clay, silts, and fine grained sands. This high velocity water carries fine sediments and nutrients into the lakes, at once disturbing the landscape and polluting the water with nitrate from acid precipitation, as well as metals, suspended solids, and hydrocarbons from the road surfaces.

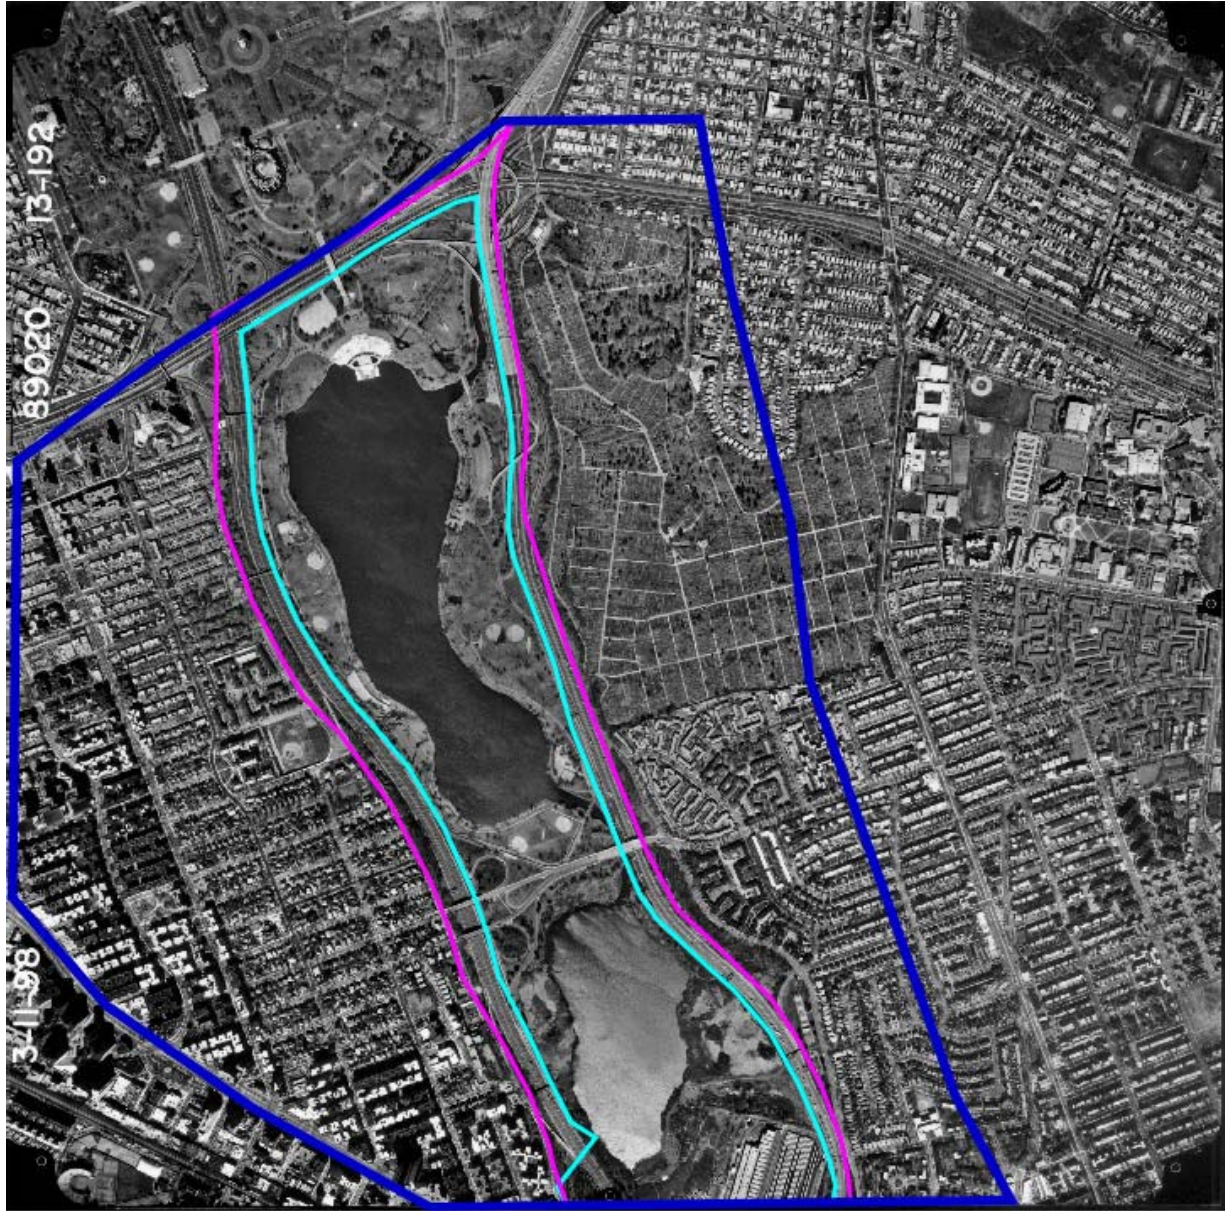
Park Watershed	270 acres

Roadway Watershed	75 acres

Surrounding Watershed	860 acres

The size of the watershed surrounding the twin lakes is a minimum of 1,200 acres, and probably closer to double that figure. Additional geographic analysis will be necessary to determine the precise boundaries.

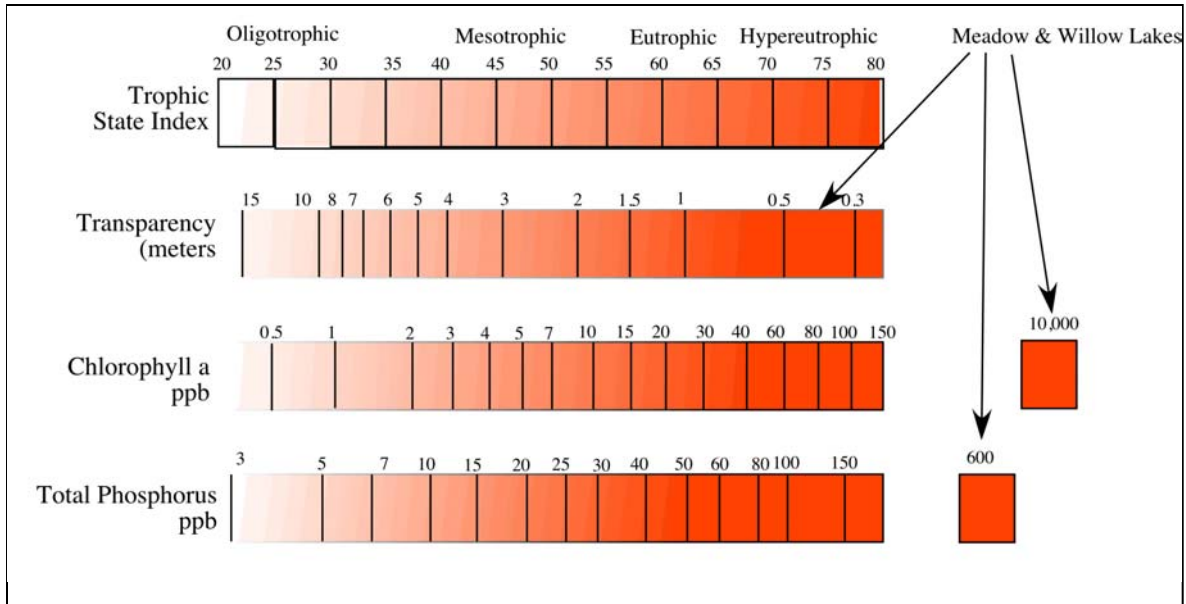
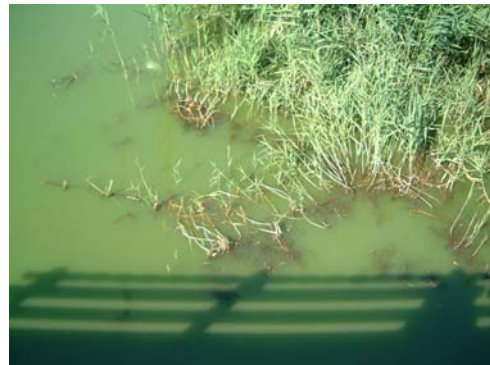
The Trophic State Index (top) is a measure of the “health” of lakes. As can be seen, measures of Meadow and Willow Lakes, reported in the Lawler, Matusky & Skelly Report, indicate values far into the hypereutrophic, or polluted, zone (from Carlson’s Trophic State Index, modified from the Lake and Reservoir Restoration Guidance Manual, 1990). This manifests itself as the “pea soup” often seen in Meadow Lake (above).

The EPA Manual (left) illustrates how human intervention speeds up the natural eutrophication process.

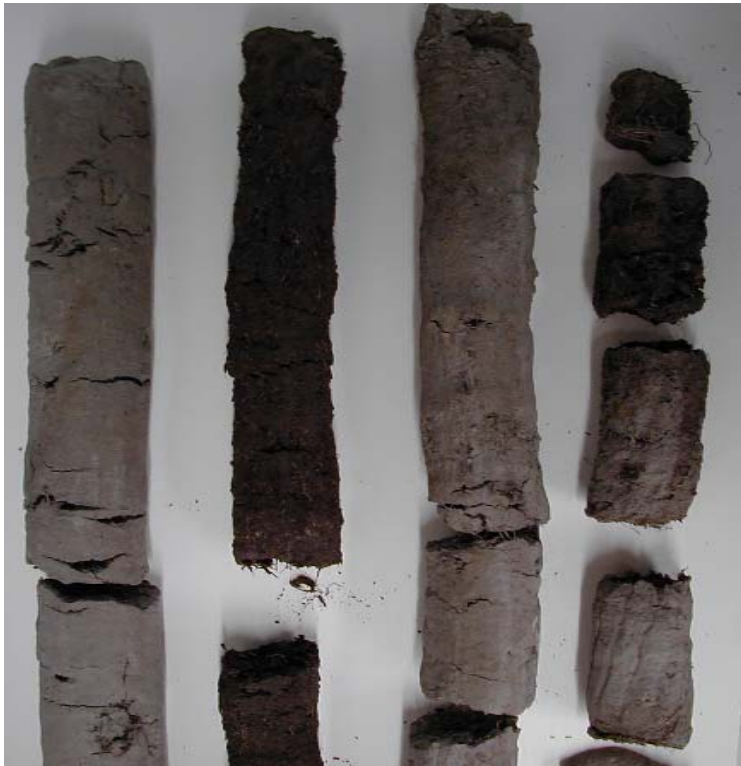
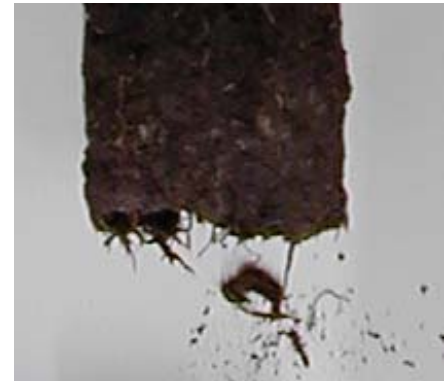
Cores taken in Willow Lake by the Gaia Institute indicate the presence of partly degraded plant material and fibers, which can be seen in the photos above and at left. The fibers, broken down plant parts and sediments comprise a deep peat layer, which may be as deep as two meters.

Cutting off sediment sources by encasing creeks, diverting stormwater through pipes, and removing most of the tidal input with the tide gate used to create the lakes, has dramatically decreased sediment input rates. This has left nutrient-rich sediments exposed at the bottom of the lakes. Without the former exposure at low tide, and without the marsh grasses to move oxygen into these sediments, they have become anaerobic, as bacteria use up available oxygen. When oxygen disappears, phosphate is released into the water, providing nutrients for algae that create thick, green “blooms.” This source of nutrients, where cores have been taken of the lake bottom, appears to be about two meters thick.

As long as these sediments remain, it is likely that the twin lakes will remain eutrophic, providing an abundant supply of the phosphorous that supports algae growth. When the algae become superabundant, as they appear to do each year, they die and provide biomass that is utilized by bacteria, depleting oxygen and releasing ammonia that is toxic to fish. This process is the probable cause of the yearly fish kills at Willow and Meadow Lakes. It is likely to continue as long as the sediments contribute nutrients to the water column.

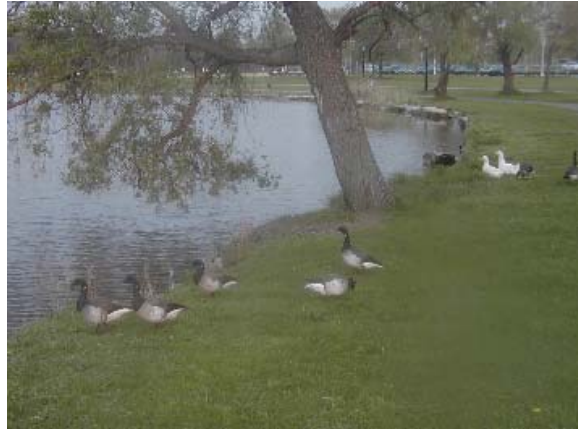
The reach of lawn-turf grass cover down to the water’s edge provides an entry and invitation to geese. Tens to hundreds of these can distribute droppings over an extensive landscape – adding yet more nutrients to an already overloaded system.

In a similar manner, the smooth banks, grassy landscape, and lack of shrub cover or dense edge vegetation makes for easy “goose walks,” or an ideal habitat that attracts these animals to congregate at the water’s edge. Their presence creates a nuisance in terms of droppings on lawns and walkways, added eutrophication from nitrogen and phosphorus, and increased fecal coliform bacterial counts in the lakes.

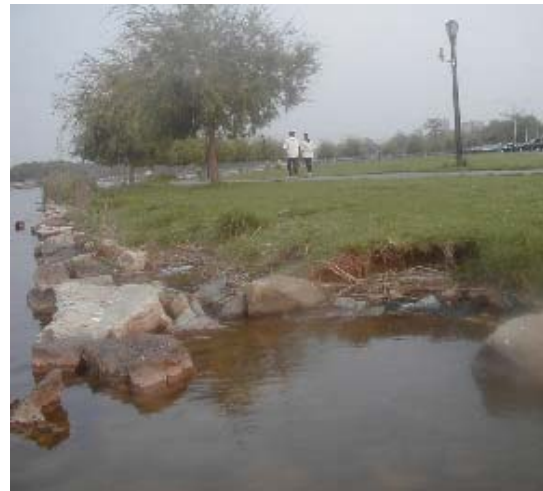
Grassy edges are readily eroded (above right). One scenario is that Nor’easters drive waves across the lake, which then undermine the shallow-rooted turf. Another is that sheet flow from lawns and walkways scour the edges while raindrops erode bare soil.

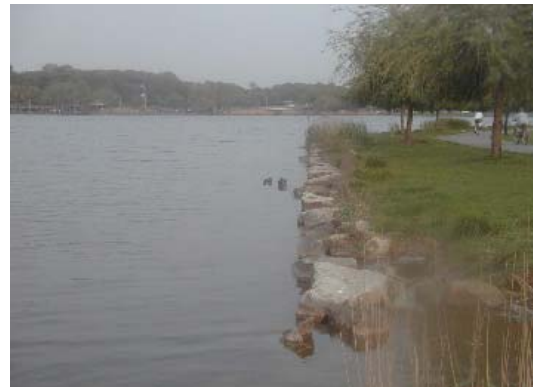
A rip-rapped or rock-lined shoreline (at right) protects against wave-driven erosion and provides some aquatic habitat, but is unproductive ecologically.

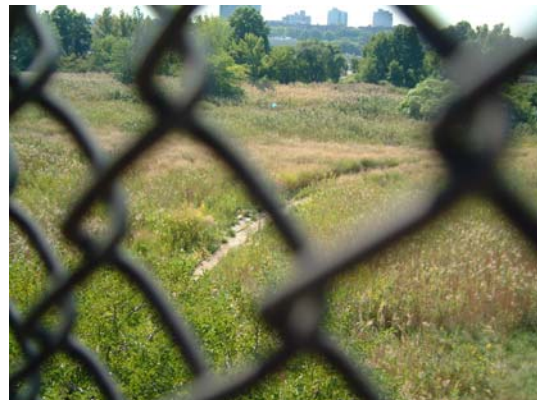
The bridge to the nature trails around Willow Lake have been closed by a chain link fence, providing no open view of the reaches of Flushing Meadows. The overgrown ball fields (visible in the 1969 aerial photograph, which can be seen on page 16) support few plant species. The extensive *Phragmites* community can be seen in the distance.

Plants: Similarly, only about 37 species of different plants have been identified in an area that should support anywhere from 300 to 400. For example, the eastern expanse of open space adjacent to Willow Lake is quite beautiful, but totally lacking in diversity. Grasses are sparsely colonized with sapling trees ten to twenty years of age. A few groups of non-native willows occur along the lake edges.
